INVENTORY OF MONUMENTS AT PAGAN

Volume One
Monuments 1-255

PIERRE PICHARD

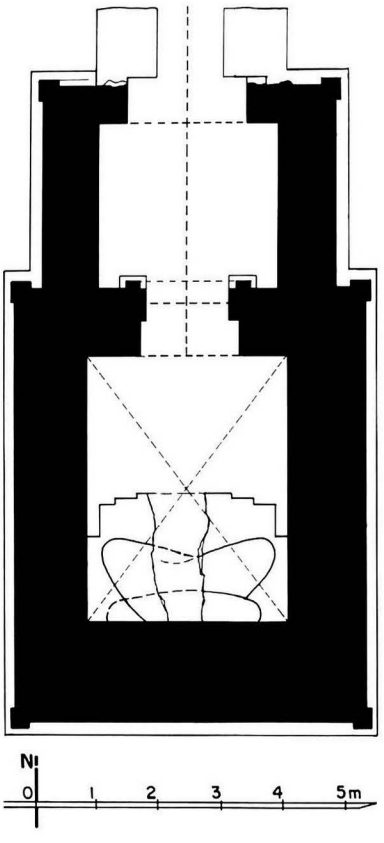
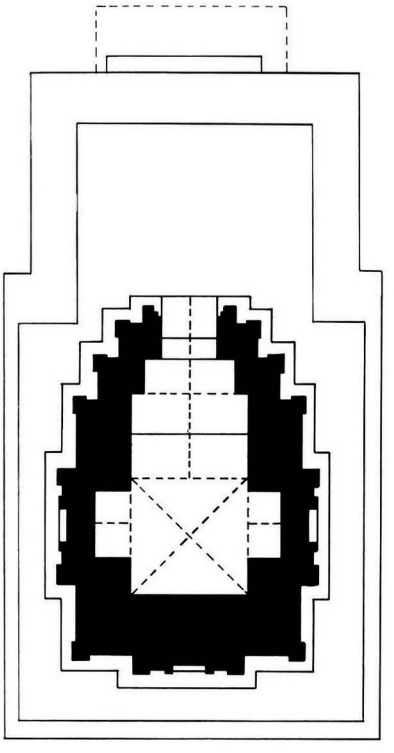
1336 a1 - Ground-floor plan

5 present condition
- maintained.
- porch collapsed.

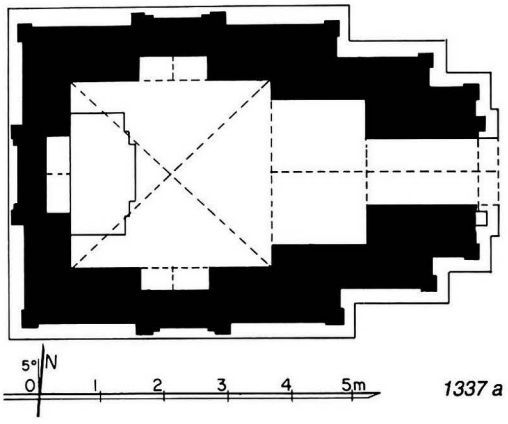
1337 a - Plan

5 present condition
- no maintenance.
- upper parts badly damaged.

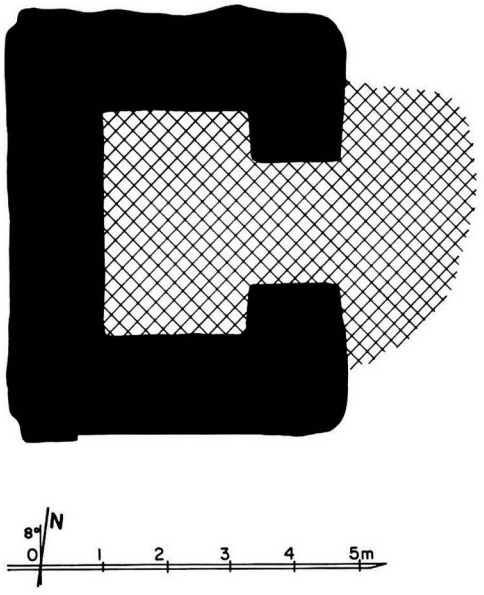
1338 a - Plan

5 present condition
- ruined.
- present height: approx. 2.20 m.

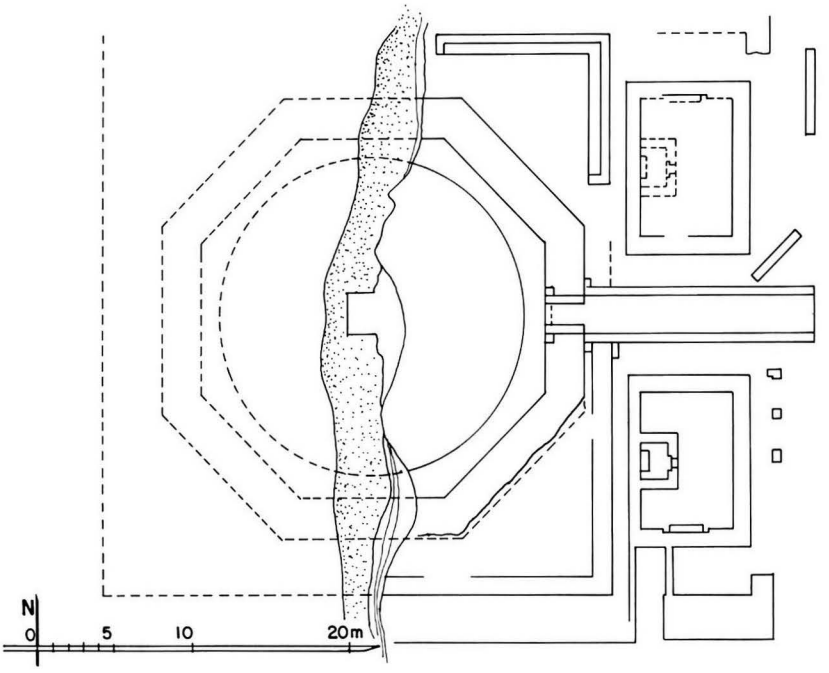
1339 a - Plan

5 present condition
- western half destroyed by erosion of river bank.
- no maintenance.
- upper parts nearly destroyed.
- partly excavated 1916 and 1927.

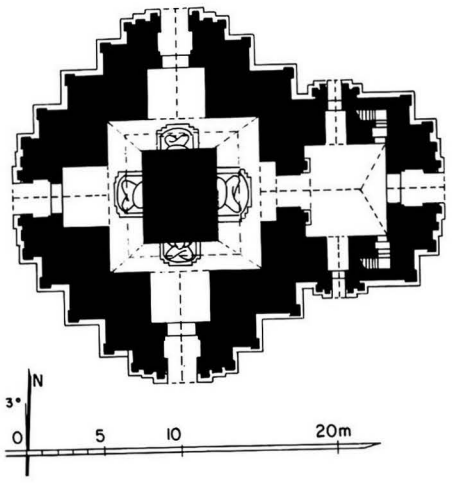
1340 a - Plan

5 present condition
- repaired (Public Works) 1990.

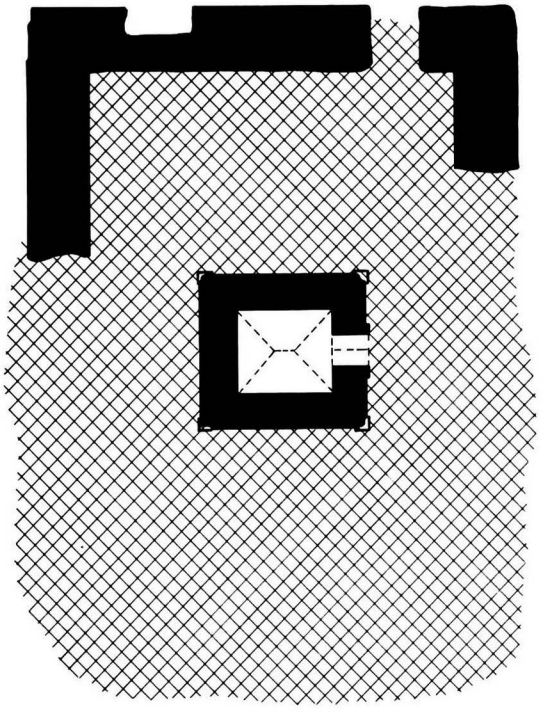
1341 a - Plan

5 present condition
- ruined.
- only northern part remains.
- ground floor buried under debris, except central cell.

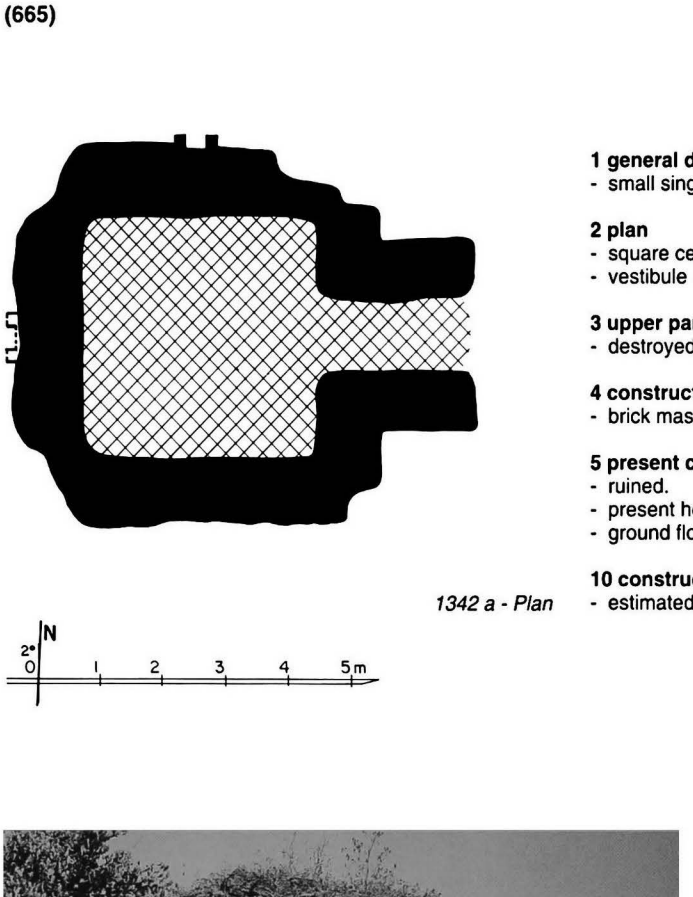
1342 b - South face

5 present condition
- ruined.
- present height 2.10 m.
- ground floor buried under debris.

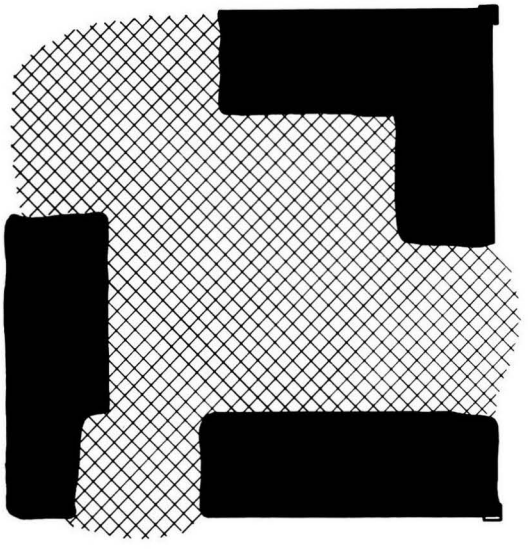
1343 a - Plan

5 present condition
- ruined.
- present height 2.40 m.
- ground floor buried under debris.

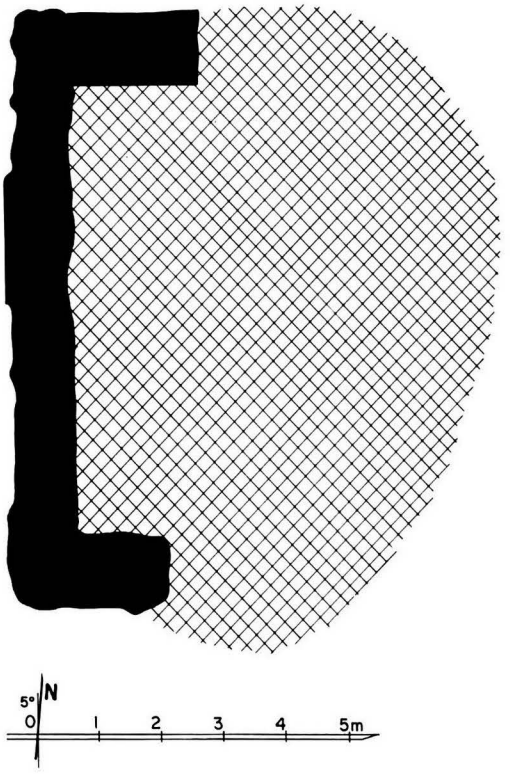
1344 a - Plan

5 present condition
- ruined.
- present height 1.80 m.
- ground floor buried under debris.

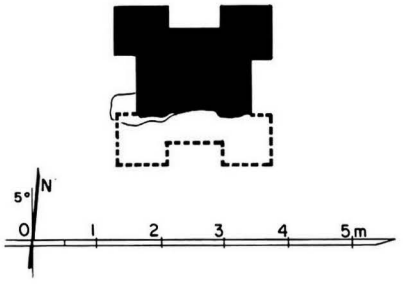
1345 a - Plan

5 present condition
- ruined.
- base and terraces disintegrated.
- upper parts collapsed.
- present height 1.40 m.

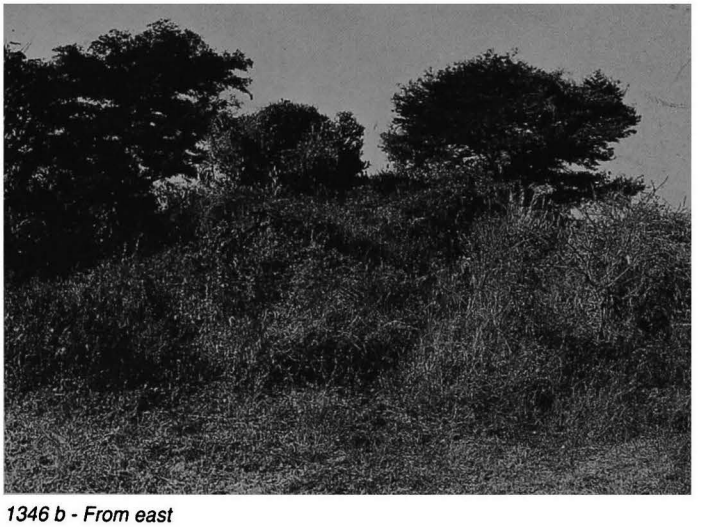
1346 b - From east

1 general description
- small unexcavated mound.

5 present condition
- brick debris.
- height: approx. 2.20 m.

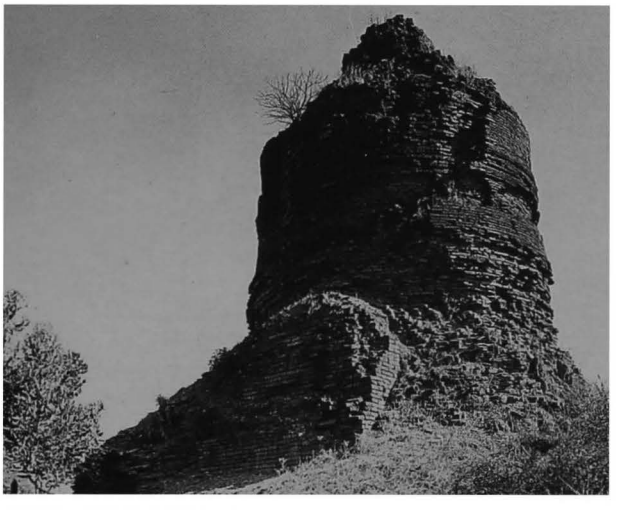
1347 b - From south-west

5 present condition
- no maintenance.
- half-ruined.
- base and terraces disintegrated.
- upper parts badly damaged.

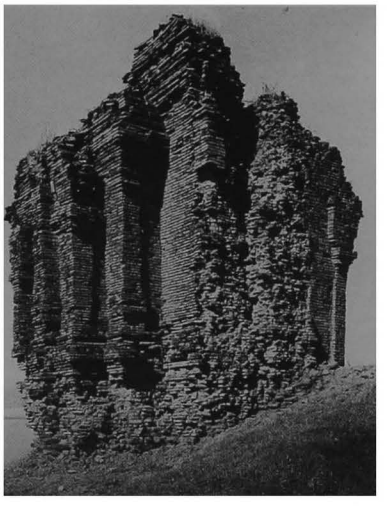
1350 d - From north-west

5 present condition
- ruined by erosion of river bank.
- only south-east corner remains.
- maintained.
- strengthened (Arch. Dept.) 1988.

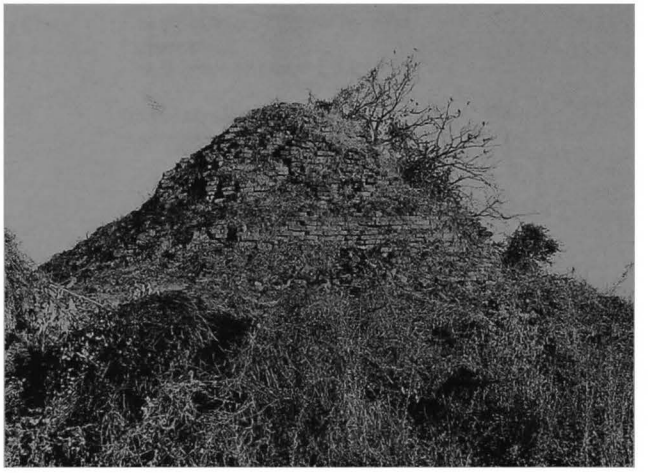
1352 c - From west

5 present condition
- ruined.
- terraces disintegrated.
- upper parts collapsed.

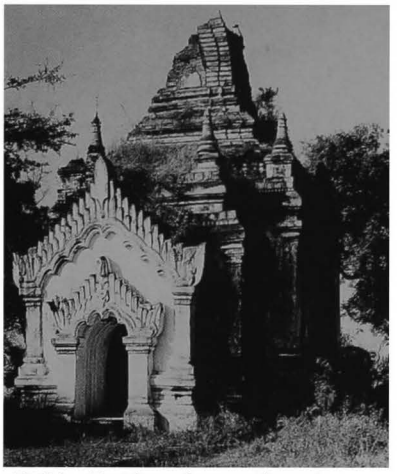
1358 b - East face, from north-east

5 present condition
- whitewashed.
- upper parts badly damaged.

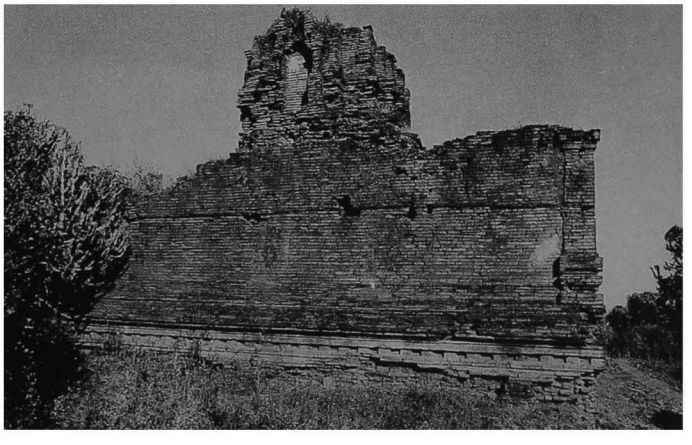
1360 e - West face

5 present condition
- no maintenance.
- half-ruined.
- ground floor buried under debris.

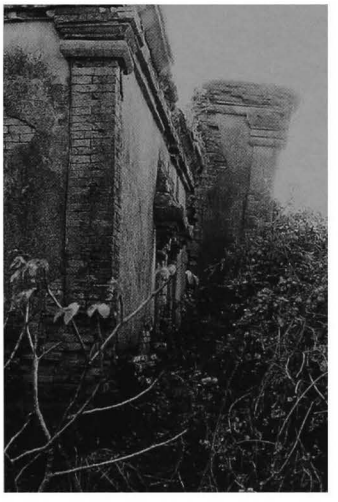
1362 c - North face, N.E. corner, from east

5 present condition
- ruined.
- vaults collapsed.
- ground floor buried under debris.

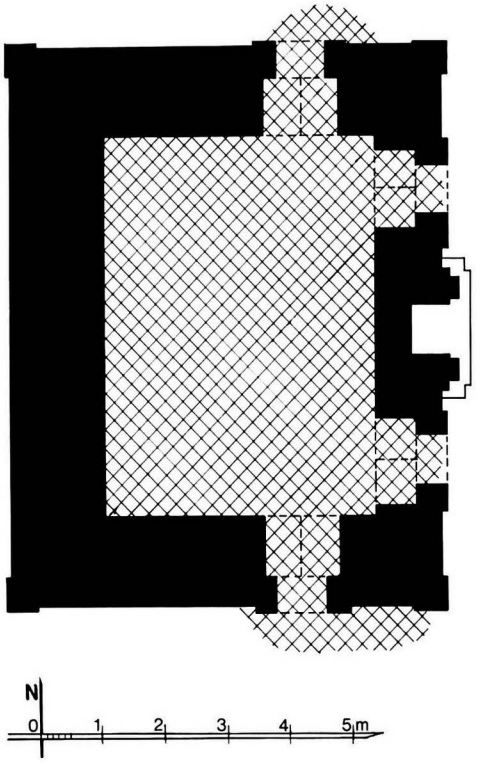
1363 a - Plan

5 present condition
- ruined.
- vault collapsed.
- ground floor buried under debris.

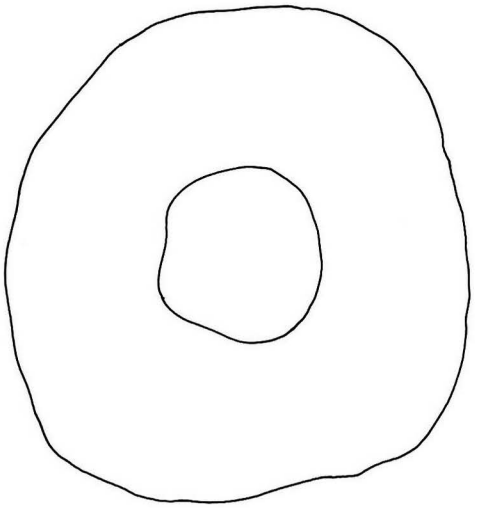
1364 a - Plan

5 present condition
- brick debris.
- height: approx. 1.20 m.

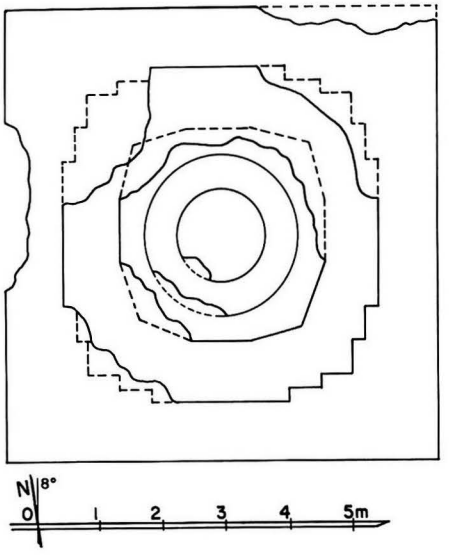
1365 a - Plan

5 present condition
- no maintenance.
- terraces disintegrated.
- upper parts damaged.

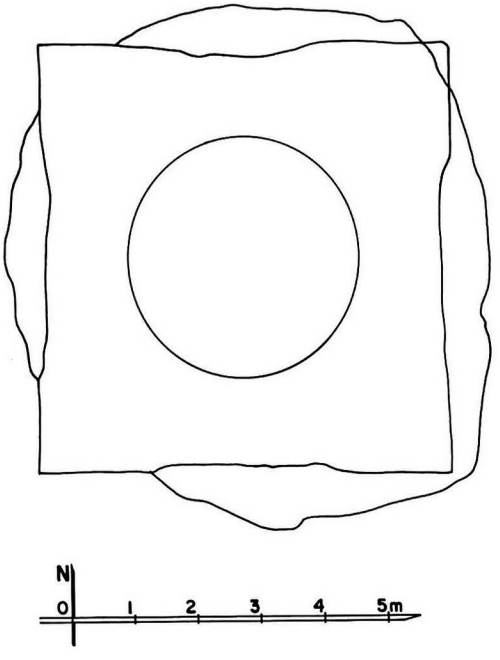
1366 a - Plan

5 present condition
- ruined.
- base and terraces disintegrated.

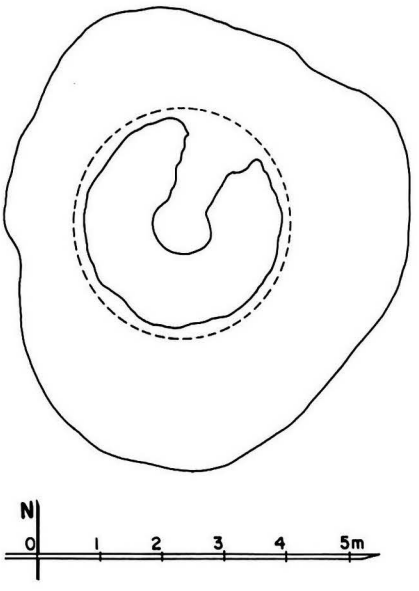
1367 a - Plan

5 present condition
- ruined.
- terraces disintegrated.
- upper parts collapsed.

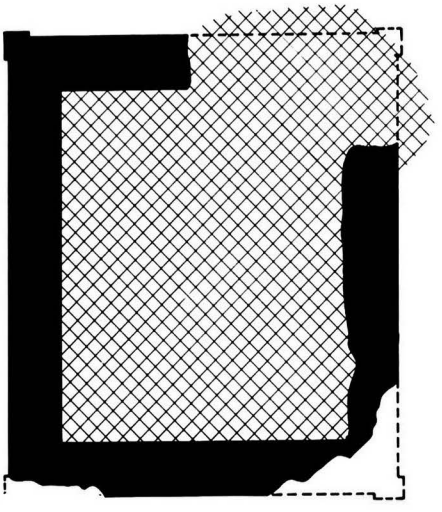
1368 a - Plan

5 present condition
- ruined.
- no more trace of vaults.
- ground floor buried under debris.

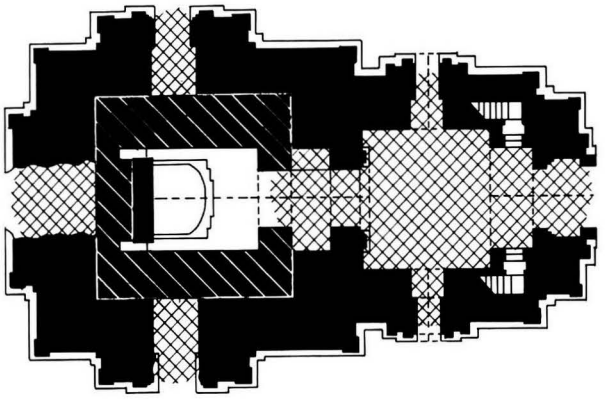
1369 a - Plan

5 present condition
- ruined.
- vaults and upper parts collapsed.
- ground floor buried under debris.
- shrine reduced by later addition of a wall.

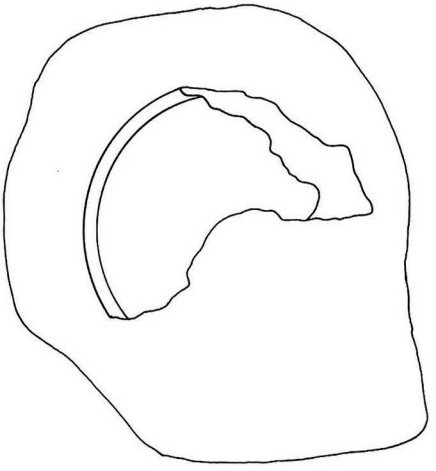
1370 a - Plan

5 present condition
- ruined.
- base and terraces disintegrated.
- upper parts nearly destroyed.

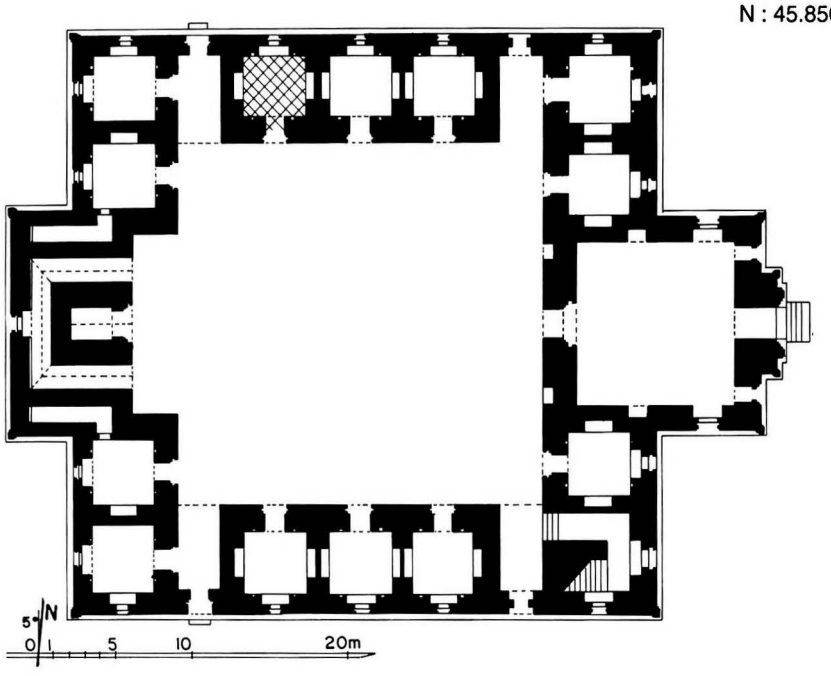
1371 a - Plan

5 present condition
- vaults, upper storey and roofs collapsed.
- cleared of debris 1971.

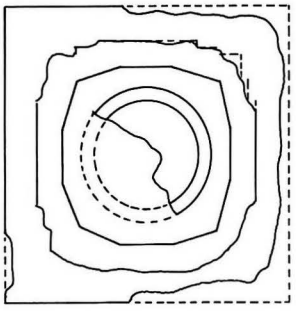
1373 a - Plan

5 present condition
- no maintenance.
- half-ruined.
- base and terraces damaged.
- upper parts badly damaged.

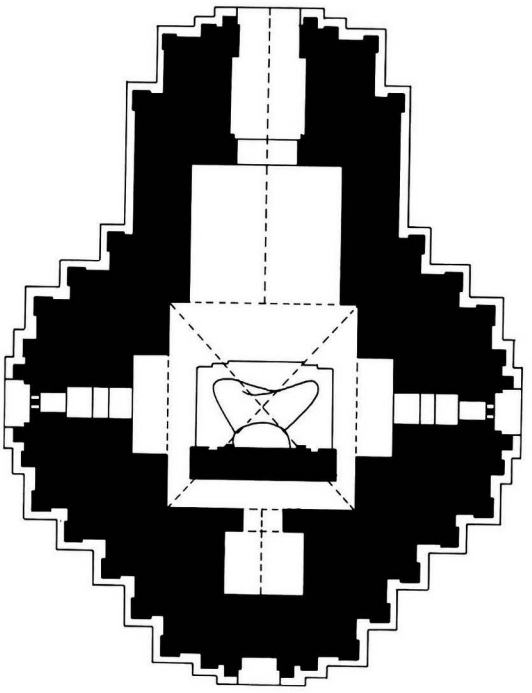
1374 a - Plan

5 present condition
- maintained.
- terraces damaged.

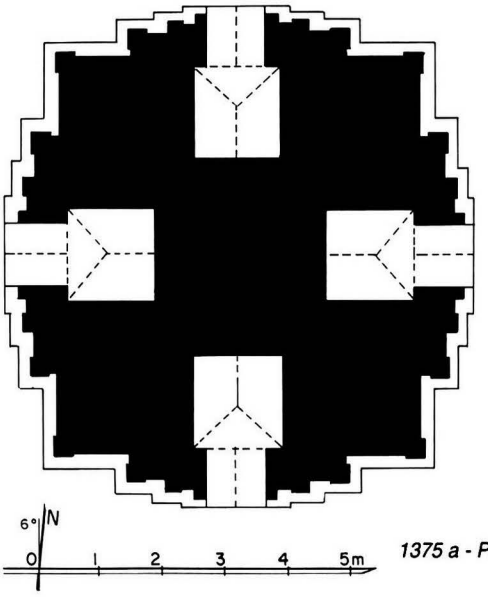
1375 a - Plan

5 present condition
- no maintenance.
- porches damaged.
- upper parts damaged.

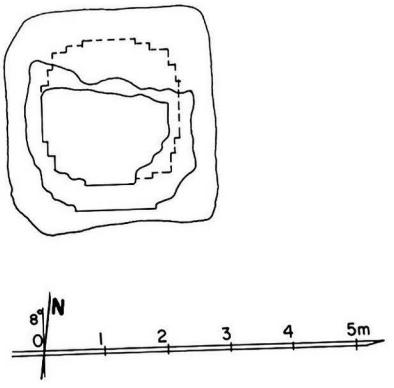
1377 a - Plan

5 present condition
- ruined.
- terraces disintegrated.
- upper parts collapsed.

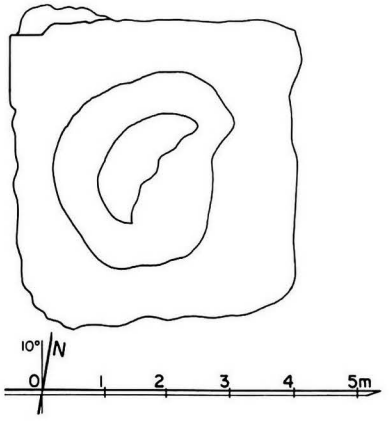
1378 a - Plan

5 present condition
- ruined.
- base and terraces disintegrated.
- upper parts nearly destroyed.

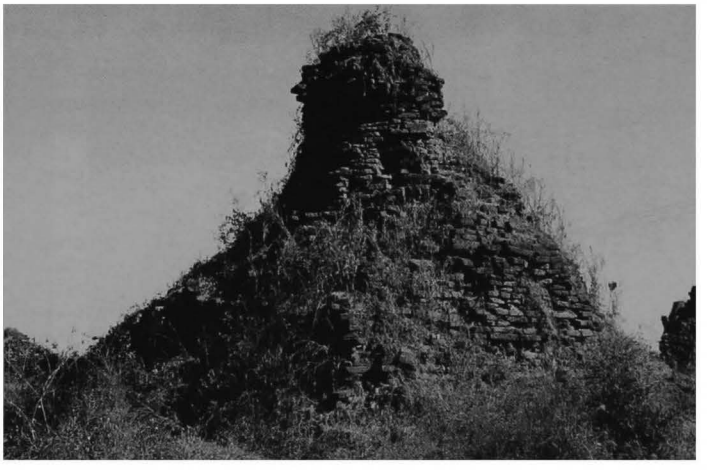
1378 b - From south, together with 1377

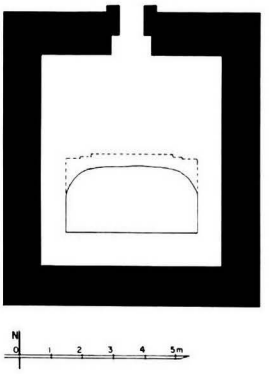
1380 a - Plan

5 present condition
- ruined.
- only base of walls remains.
- present height 1.50 m.

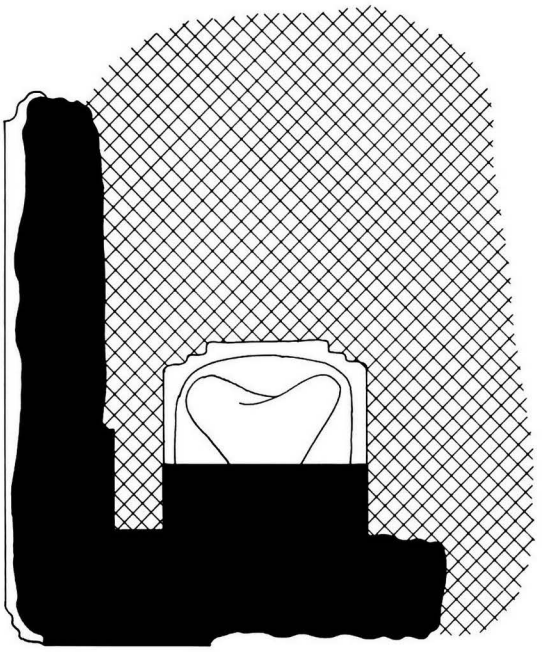
1381 a - Plan

5 present condition
- ruined.
- only base of south and west walls remains.
- vaults and upper parts collapsed.
- ground floor buried under debris.

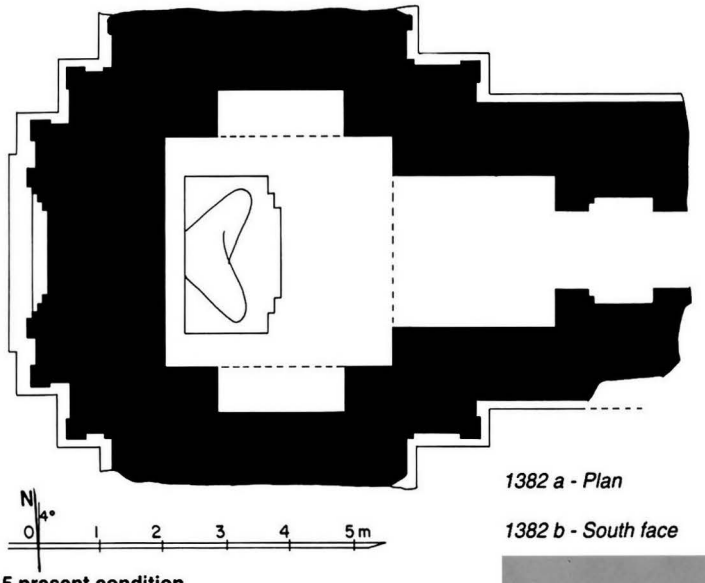
1382 a - Plan

5 present condition
- ruined.
- base disintegrated.
- vaults and upper parts collapsed.
- ground floor cleared of debris.

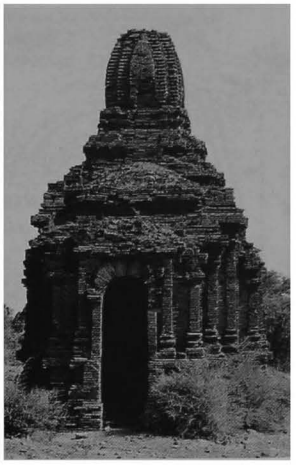
1383 c - North face

5 present condition
- no maintenance.
- upper parts damaged.

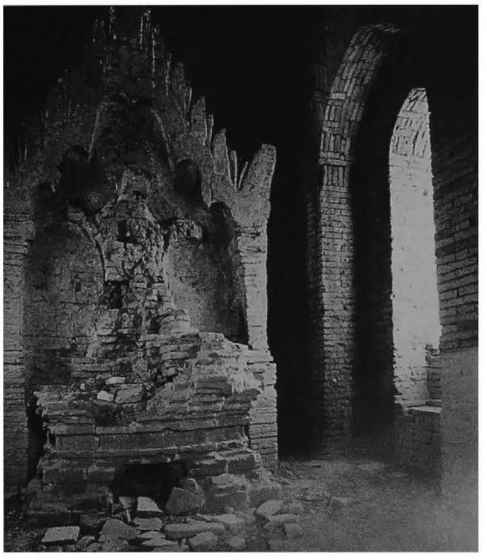
6 image
- 1 seated Buddha, facing north (badly damaged and headless), against a screen wall.

1383 e - Shrine, screen wall and image, from north-east

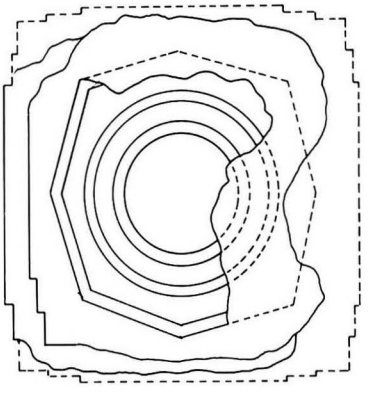
1384 a - Plan

5 present condition
- no maintenance.
- half-ruined.
- base disintegrated.
- upper parts nearly destroyed.

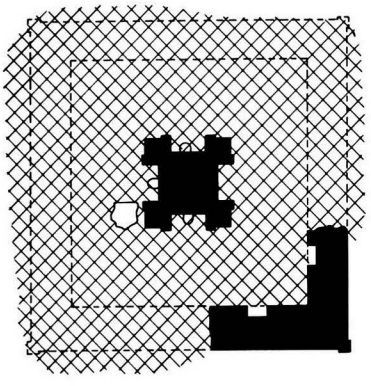
1385 a - Plan

5 present condition
- no maintenance.
- half-ruined.
- outer wall collapsed except south-east corner.
- vault over corridor collapsed.
- ground floor buried under debris.

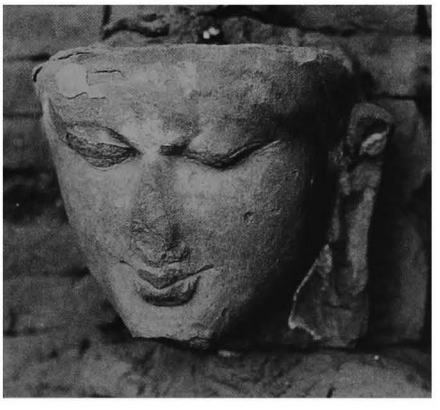
6 images
- 4 seated Buddhas in niches, with fine stone heads (destroyed on east, brick body damaged on south, west and north).

1385 e - West image, detail of head

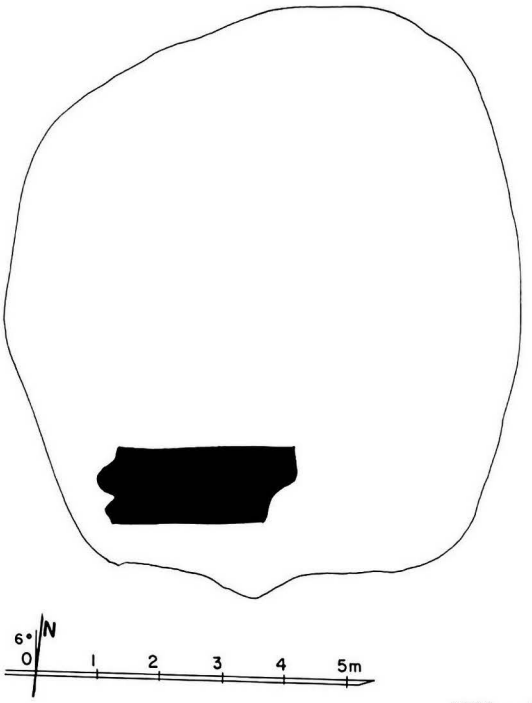
1386 a - Plan

5 present condition
- only part of a south wall remains.
- height: approx. 2.00 m.

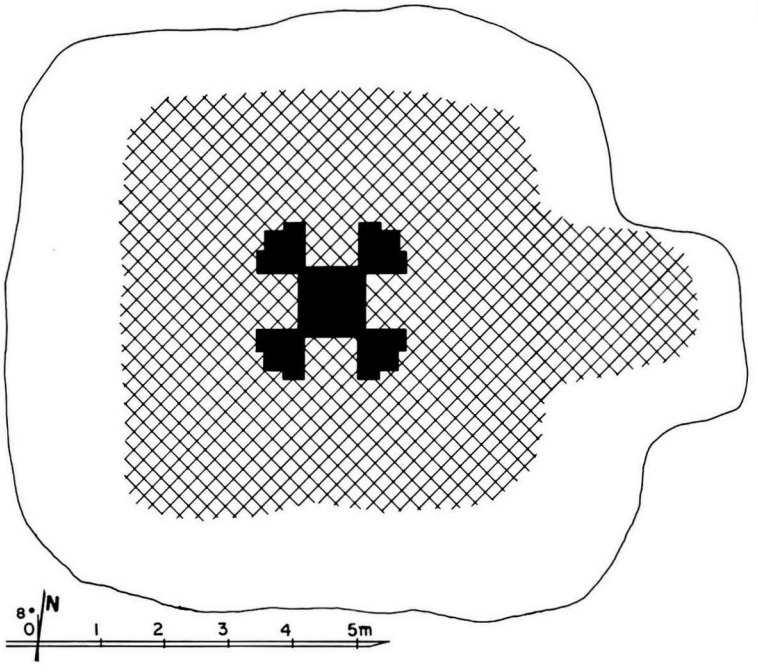
1387 a - Plan

5 present condition
- no maintenance.
- half-ruined.
- outer wall and vault over corridor collapsed.
- ground floor buried under debris.

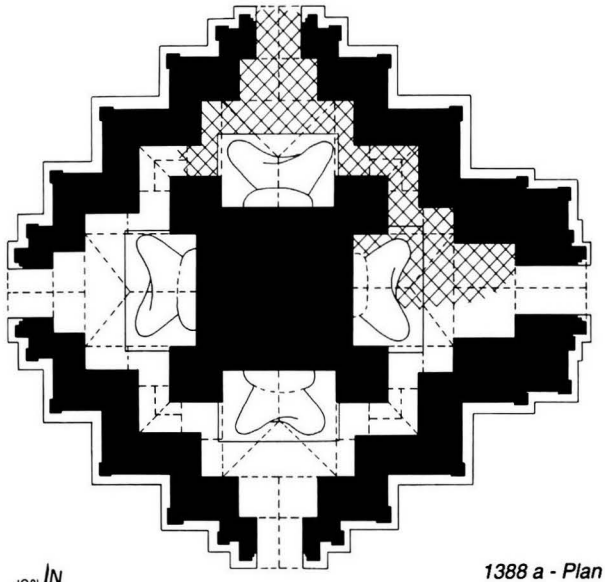
1388 a - Plan

5 present condition
- no maintenance.
- structure badly cracked.
- porches damaged.
- vaults over north shrine collapsed.
- upper parts badly damaged.
- ground floor partly buried under debris.

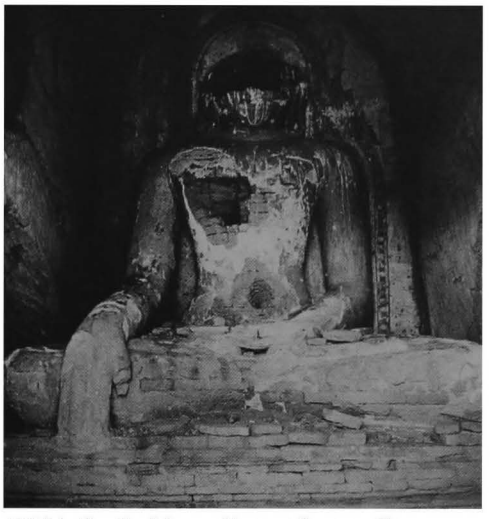
1388 f - South niche and image, from south

6 images
- 4 seated Buddhas (damaged and headless).

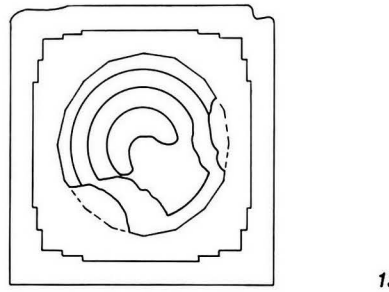
1389 a - Plan

5 present condition
- no maintenance.
- base disintegrated.
- upper parts nearly destroyed.
- upper parts badly damaged.

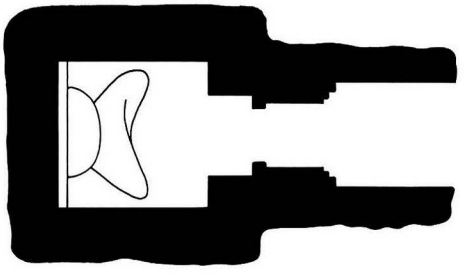
1390 a - Plan

5 present condition
- ruined.
- external face of walls disintegrated.
- vaults and upper parts collapsed.
- partially cleared from debris.

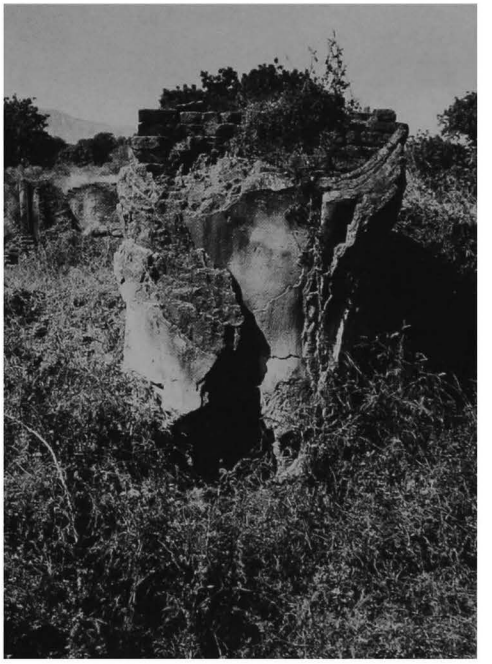
6 image
- 1 seated Buddha, facing east (damaged and headless).

1390 d - Remaining part of image, detail from east

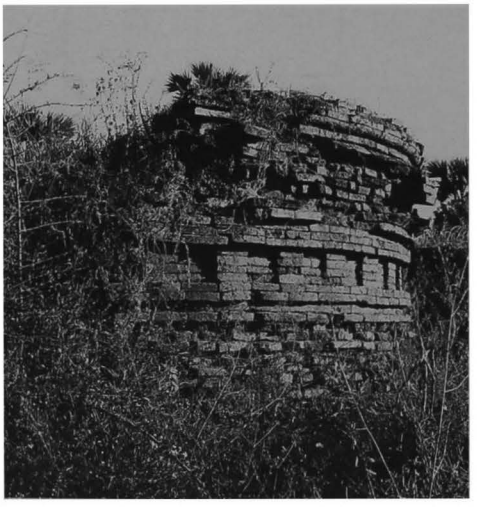
5 present condition
- ruined.
- only west part of base remains.

1395 d - From west

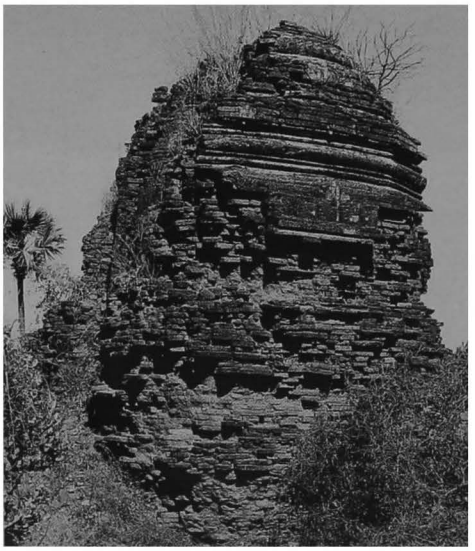
5 present condition
- half-ruined.
- base and terraces disintegrated.
- upper parts destroyed.

1397 b - South face, from south-west

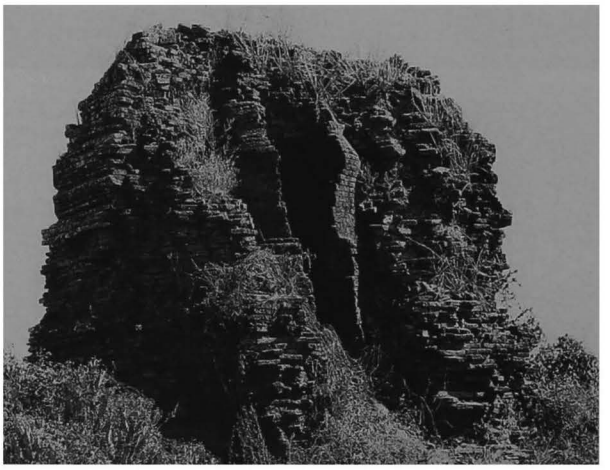
1397 c - From north-west, encased stupa

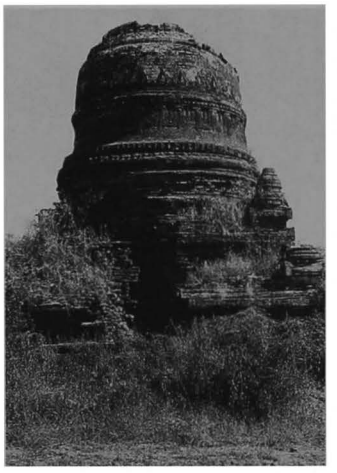
5 present condition
- no maintenance.
- terraces damaged.
- upper parts partly destroyed.

1399 d - From west

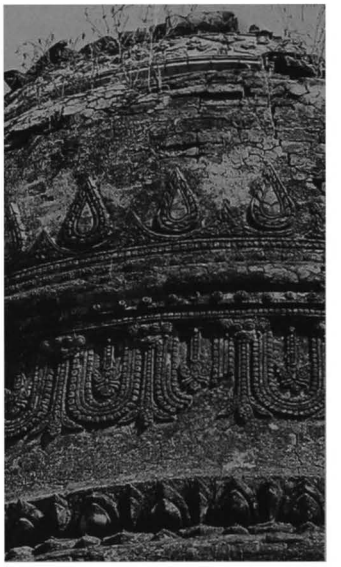
7 decoration
- stucco mouldings, still in place: 25%.
- plain stucco mouldings on base and terraces.
- dado with inverted obovals, ornate waistband and frieze with ogre heads around dome.

1399 e - Dome detail, from west

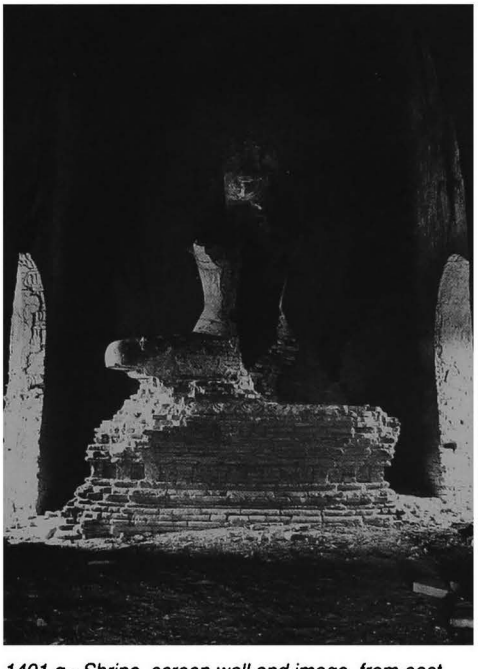
6 image
- 1 seated Buddha, facing east (damaged and headless), against a screen wall.

1401 g - Shrine, screen wall and image, from east

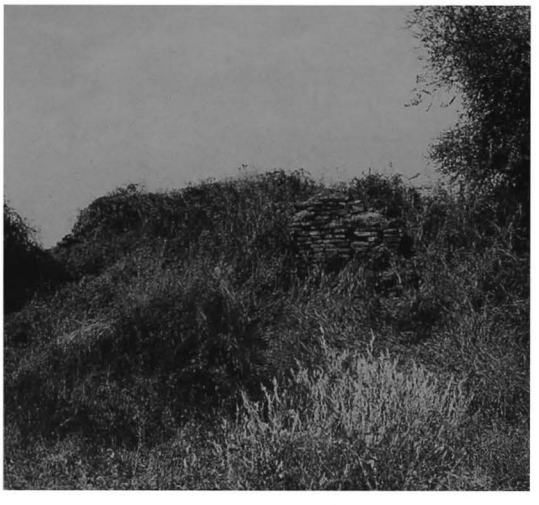
5 present condition
- only part of west and south walls remains.
- height: approx. 4.20 m.

1402 b - From south-east

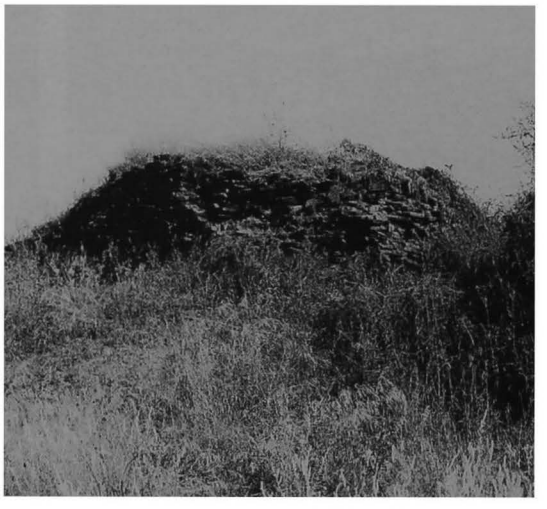
1402 c - From south-west

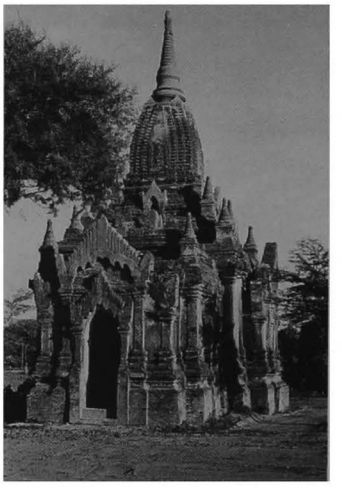
5 present condition
- regularly maintained by Thiripyitsaya Hotel.
- repaired 1987.
- brick grilles built by Arch. Dept.

1404 e - North face, 1987, after repair

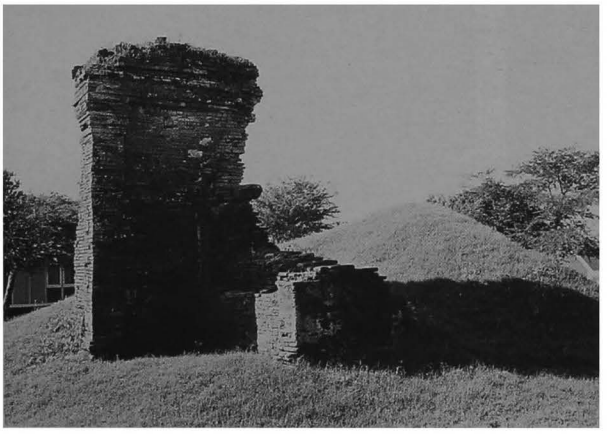
5 present condition
- only parts of west wall and north-east corner remain.
- maintained and planted with grass by Thiripyitsaya Hotel.

1408 c - From north-east

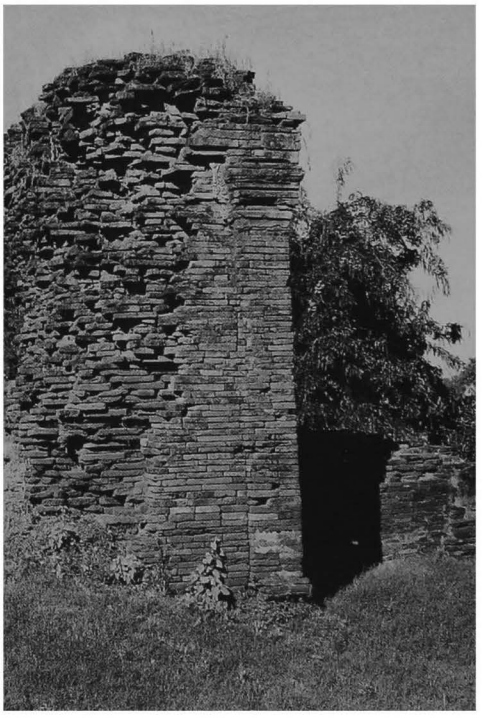
1408 d - East face, remaining north part

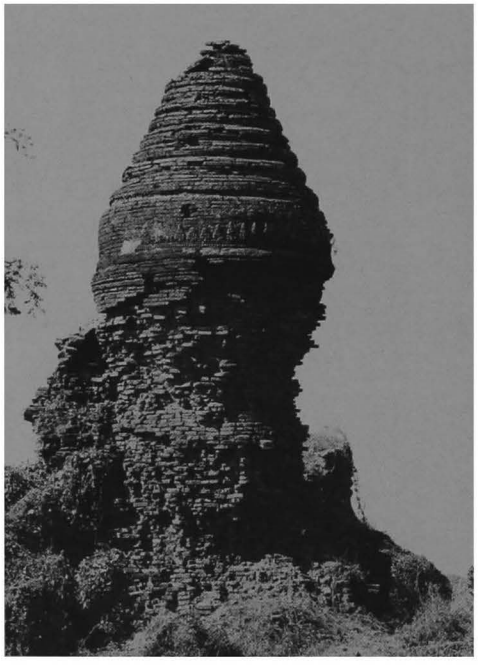
1411 b - From east

5 present condition
- no maintenance.
- half-ruined and endangered.
- base and terraces disintegrated.
- upper parts badly damaged.

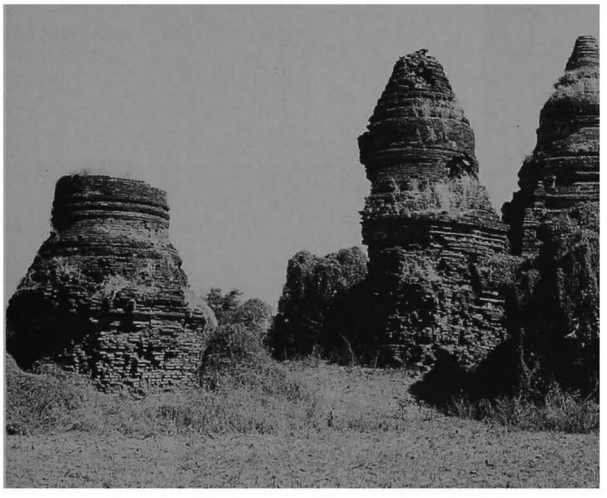
1412 b - From south, together with 1411 and 1410

5 present condition
- no maintenance.
- base and terraces disintegrated.
- upper parts half destroyed.

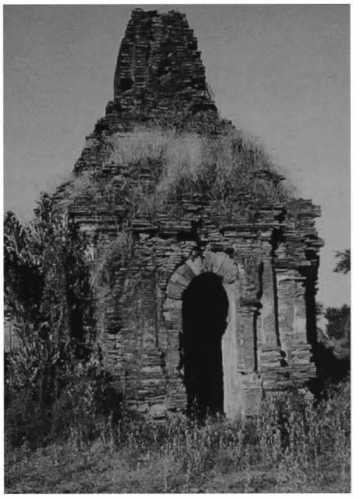
1416 c - East face

5 present condition
- no maintenance.
- upper parts badly damaged.

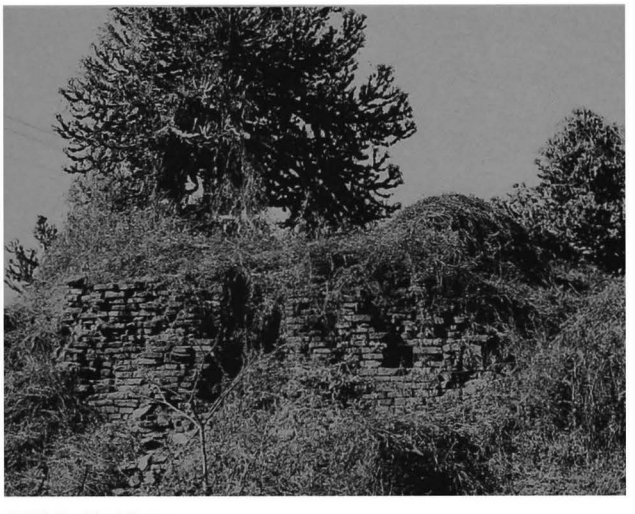
1418 b - East face

5 present condition
- ruined.
- walls and vault collapsed.
- ground floor buried under debris.

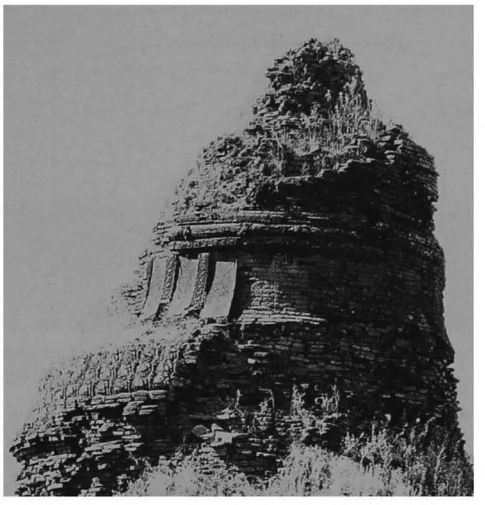
1420 b - Upper parts, from south-east

5 present condition
- no maintenance.
- terraces and upper parts badly damaged.

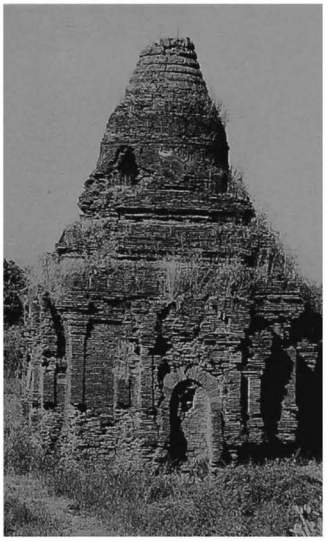
5 present condition
- regularly maintained.
- repaired (Arch. Dept.) 1991-92.

1422 d - East face, 1987

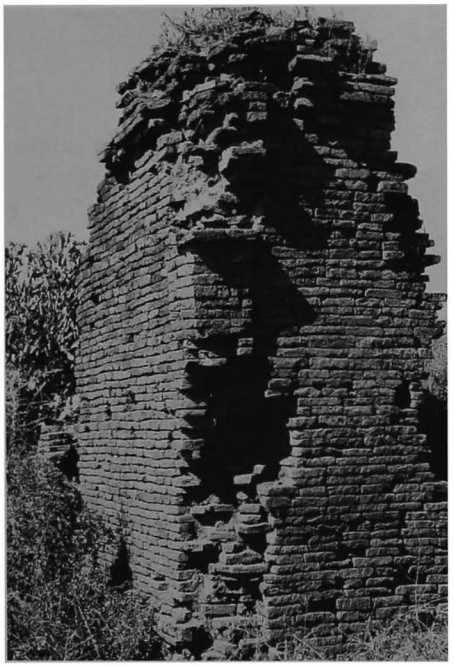
5 present condition
- ruined.
- only north-west and south-east corners remain.
- ground floor buried under debris.

1424 b - South-east corner, from south-east

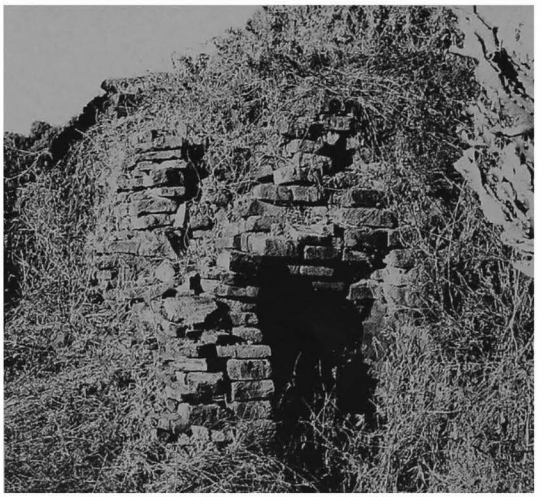
5 present condition
- ruined.
- only north part remains.
- present height 2.40 m.
- ground floor buried under debris.

1429 b - South-west corner, from south

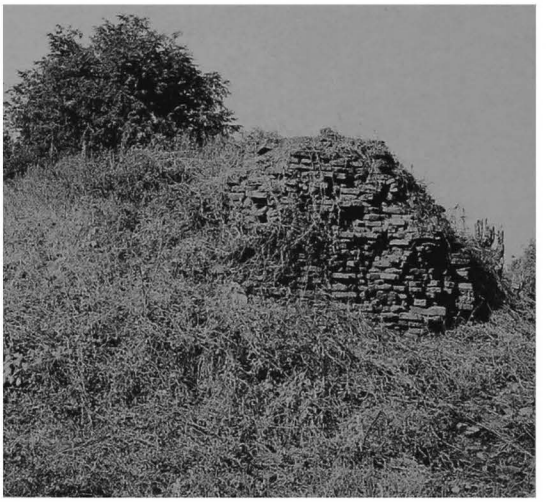
1429 c - From west

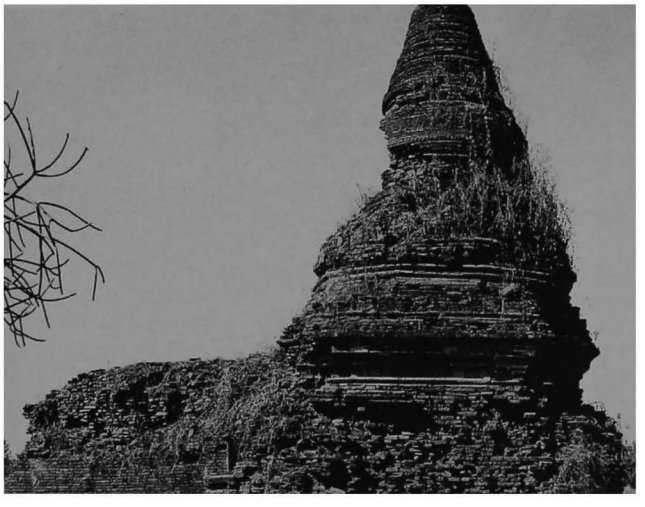
5 present condition
- half-ruined.
- terraces disintegrated.
- upper parts badly damaged.

1432 b - East face

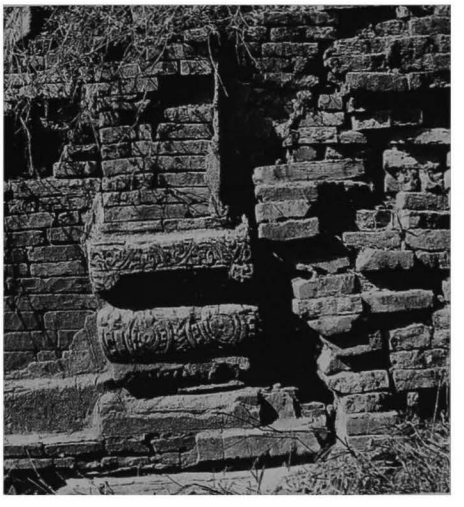
1432 c - East face, detail of joint between south shrine and stupa

remark
- ancient lists record 4 shrines (1 on each side of stupa). Only 2 are now present, and they are clearly an addition to the completed and plastered stupa.

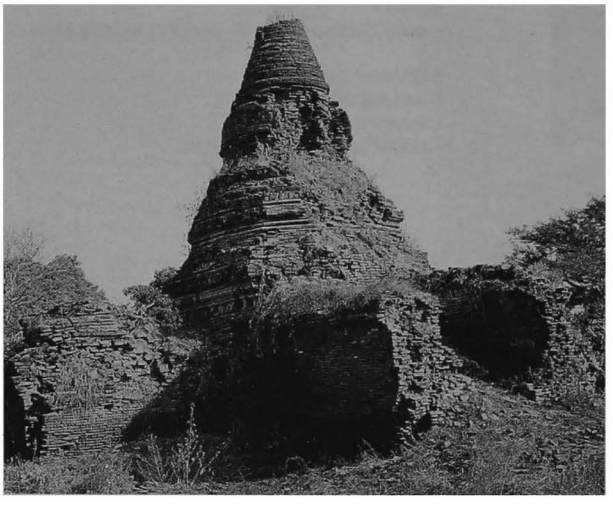
1432 e - From south-west

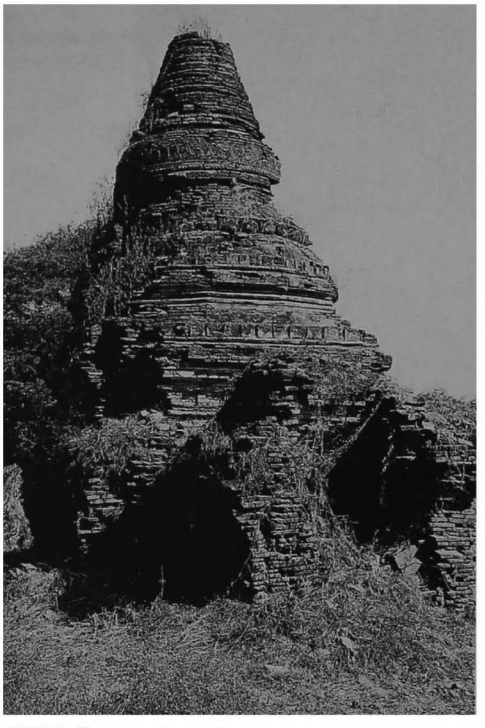
1432 f - From north-west

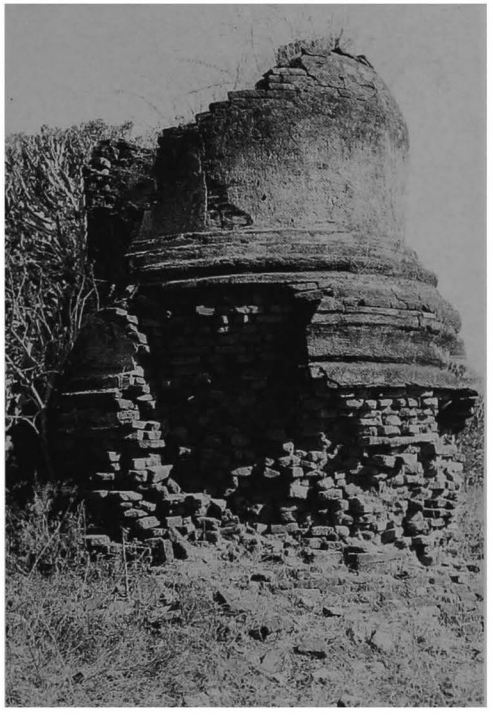
5 present condition
- no maintenance.
- terraces and upper parts badly damaged.

1438 b - From south-west

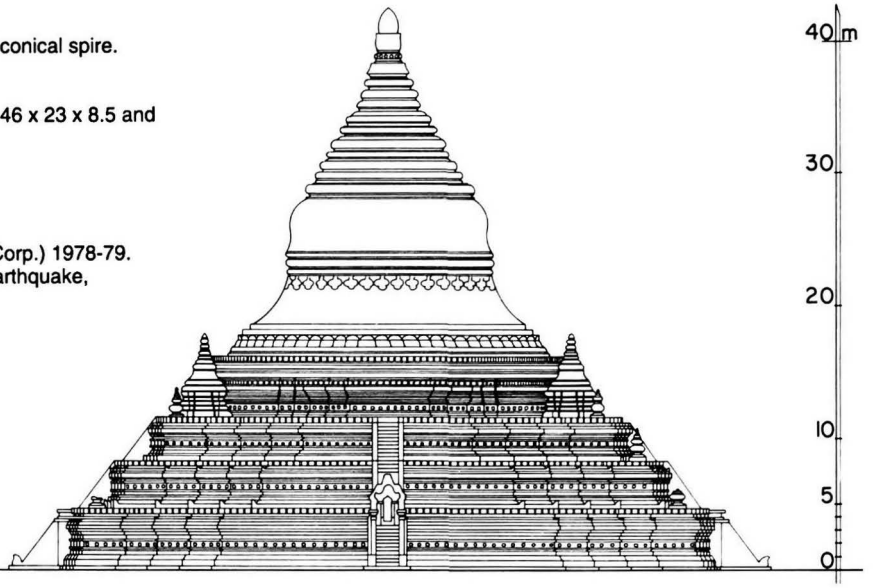
5 present condition
- regularly maintained.
- repaired 1908-9 and (Const. Corp.) 1978-79.
- spire damaged by the 1975 earthquake, repaired 1976.

1439 a2 - West elevation
